Guidelines for facilities for  
blind and vision-impaired  
pedestrians

*RTS 14*

Revised September 2003  
First issued June 1997 (reprinted June 1998, September 2001)

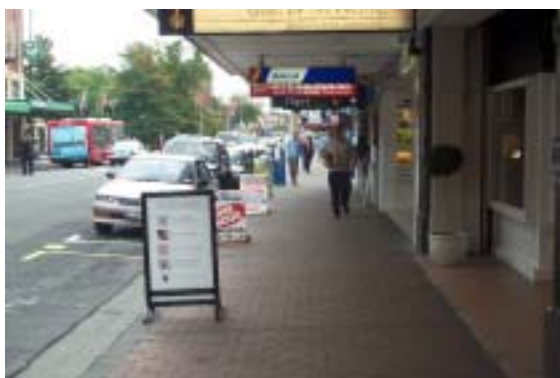
*Photo 1: Advertising signs located on the kerb edge, outside the continuous accessible path of travel.*

Advertising signs on the footpath should be avoided if possible. Where advertising is permitted, signs shall be located away from the continuous accessible path of travel, i.e. on the kerb edge, as shown in Photo 1, and always placed consistently in the same location.

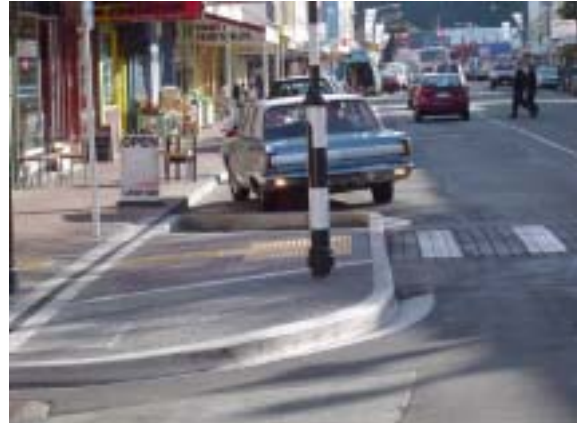
*Photo 2: The kerb protrusion at this raised pedestrian crossing reduces the crossing distance for pedestrians. Here a raised crossing slows traffic and eliminates the kerb ramp.*

A good example of a road narrowing at a pedestrian crossing point is shown in Photo 2.

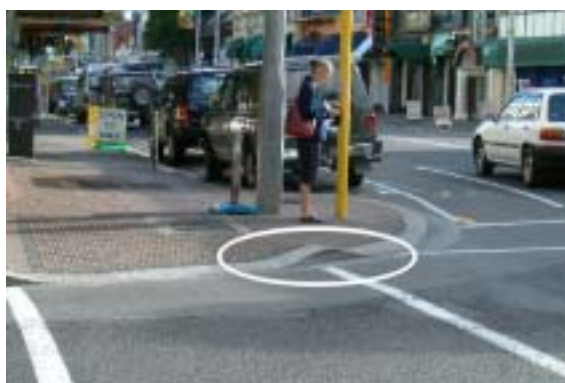
*Photo 3: The short kerb upstand between crossing points is a tripping hazard.*

Provision of two separate kerb ramps separated by a vertical kerb upstand of at least 1m long is definitely the preferred design for kerb ramps at an intersection. A kerb upstand less than 1m wide between kerb ramps can be difficult for pedestrians to detect, creating a tripping hazard (Photo 3).

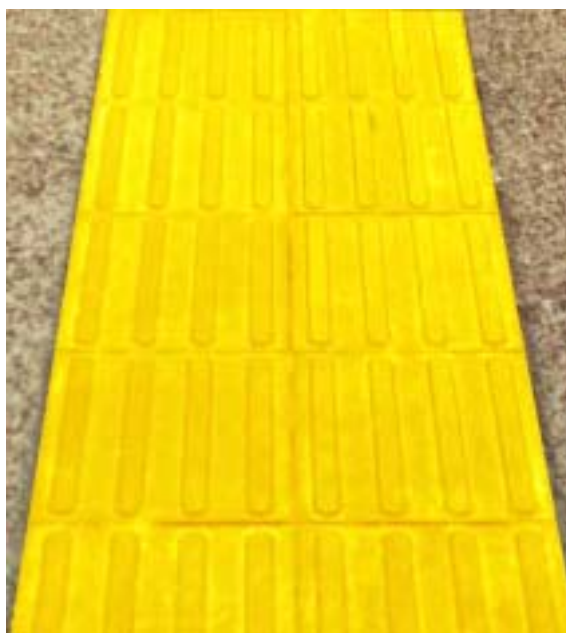
*Photo 5: View of directional indicators.*

Photo 5 shows a typical arrangement of directional indicators.

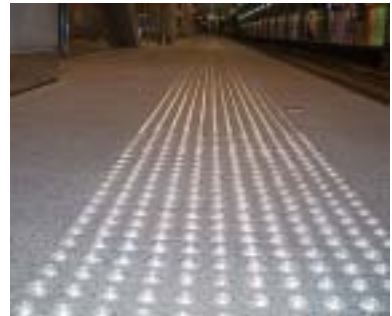
*Photo 6: The warning indicators at this railway station are 600mm deep and set 600mm back from the platform edge. While these warning indicators look like they provide little contrast, the stainless steel design does comply with visual contrast requirements.*

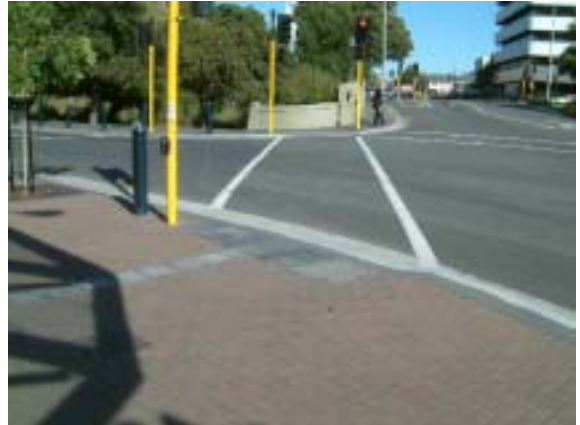
*Photo 7: Not good practice: The call box, warning and directional indicators are aligned with the kerb instead of the crossing direction. A blind or vision-impaired person could easily lose their orientation at this intersection and walk into a dangerous situation. There is also poor visual contrast between the TGSIs and surrounding footpath surface.*

- With the front and back edges perpendicular to the crossing direction to enable blind and vision-impaired people to align themselves correctly (refer to Photo 7 for how NOT to do it).
- So that the domes are aligned with the direct line of travel across the road.
- So that the front edge of the warning indicator is no closer than 300mm from the edge of the hazard, except at railway platforms or wharves where the setback from the hazard must be a minimum of 600mm.
- To a recommended depth of 600mm and up to 900mm where additional warning is considered necessary.  
(This depth is required to prevent a pedestrian from inadvertently stepping over the TGSI.)
- To within 500mm of the base of traffic signals so that pedestrians can stand on the warning indicators when using ATTS.
- So that the base of the warning indicators are flush with the surrounding footpath surface.

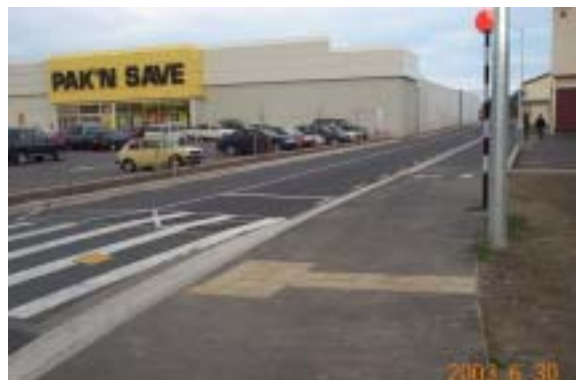
*Photo 8: These directional indicators intercept all pedestrians on the continuous accessible path of travel. They lead directly to the warning indicators, which are aligned with the centre of the pedestrian crossing.*

In most cases, the footpath will run parallel to the roadway and thus the crossing point will not be on the continuous accessible path of travel (Photo 8).

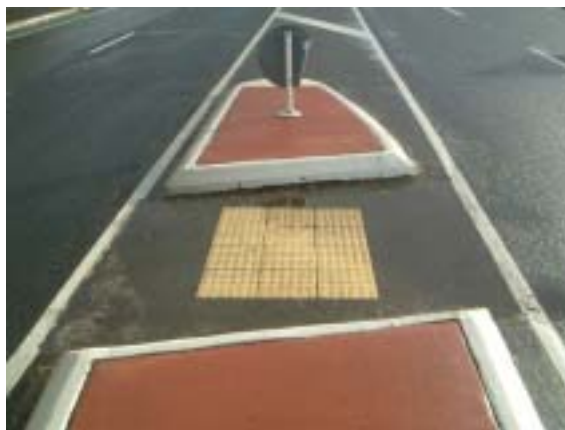
Photo 9: Warning indicators correctly installed across the full depth of this pedestrian median island (1.2-1.8m deep).  
Note: Warning indicators should cover full width of cut through. This one could be bypassed.

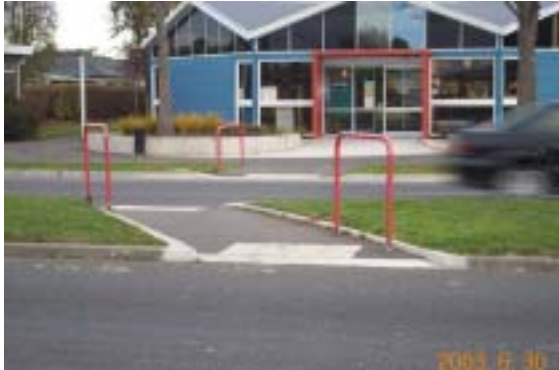
*Photo 10: On deep medians two sets of warning indicators are installed. (Note: not quite full width.)*

Where the median is more than 1.8 m deep, two sets of warning indicators each 600mm deep, shall be installed, set back 300mm from the roadway (photo 10).

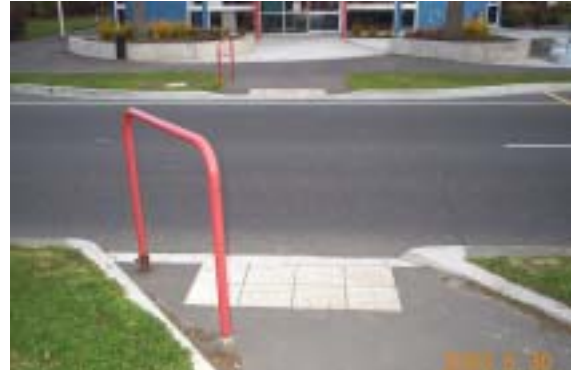
*Photo 11: The warning indicators are aligned with the road crossing direction. (Note: not quite full width.)*

Where the cut through of a median is angled, the warning indicators must be installed so that they are aligned with the direct road crossing line (photo 11).

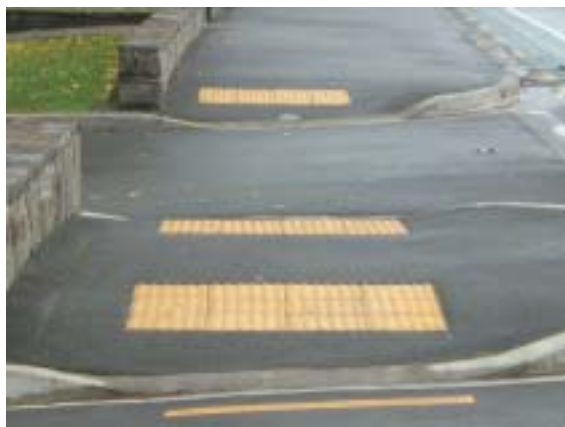
*Photo 12: Warning indicators should be installed at all intersections, no matter how minor.*

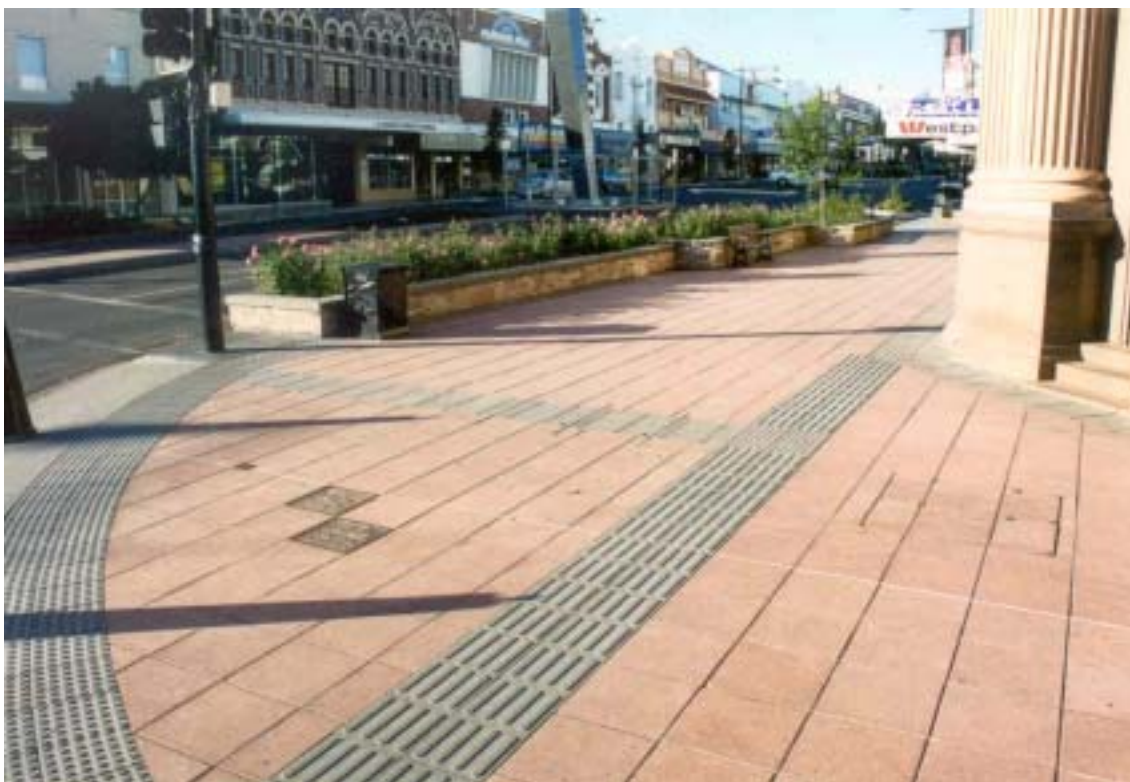
*Photo 13: Directional and warning indicators installed at a signalised scramble crossing.*

Photo 13 shows an example of a blended kerb at a wide footpath with large corner radius. Note how the directional indicators link to the building line to intercept the direction of pedestrian movement and lead blind and vision-impaired users to the warning indicators by the call box. This design could be further improved by rotating the call box so that it is mounted perpendicular to the pedestrian path of travel. See figure 5f for a better warning indicator arrangement for the scramble crossing.

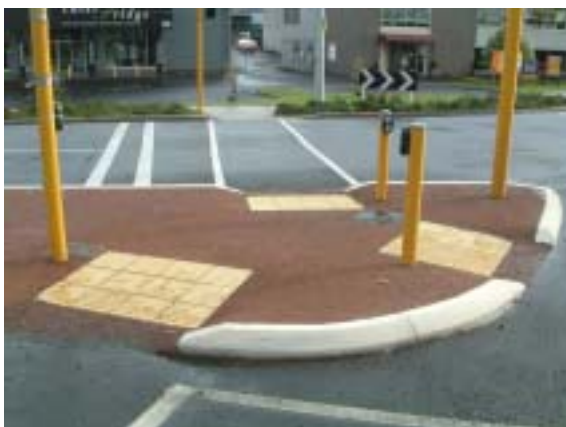
Photo 14: Warning indicators correctly installed on this slip lane island, in regard to alignment and position. Cutting the island through level with the roadway would improve guidance across the island and accessibility for mobility-impaired people. In the absence of the cut-through directional TGSi should be considered. Also note how exclusive pedestrian push button poles have been provided adjacent to each crossing point (refer Section 5.5 for guidance).

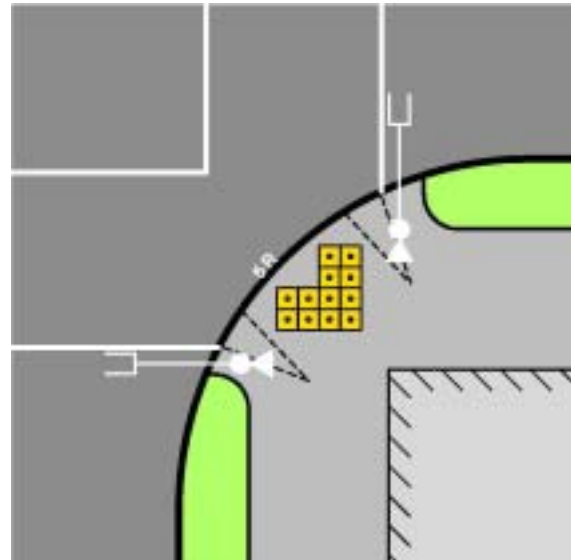
Figure 5d: Single angled crossing.

**Kerb ramp design not recommended.  
TGSIs arrangement acceptable.**

This TGSIs arrangement gives the least confusing crossing information for this situation, and intercepts a higher proportion of the approach path.

- Redesign the kerbs and/or crossing points as outlined above.
- Provide the least confusing arrangement of TGSIs possible, as shown in figure 5d.

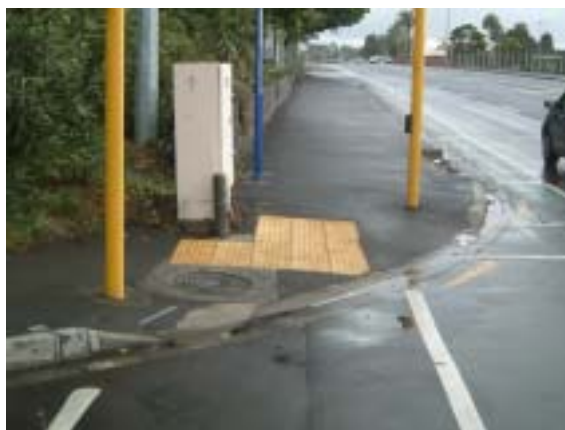
*Photo 15: Although not fully compliant, the TGSI convey warning and directional information to blind and vision-impaired pedestrians that encounter them, but it is quite possible to step past them and miss the warning.*

Photo 15 shows an attempt at providing TGSI at a corner with utility services, a narrow footpath, and large curve radius.

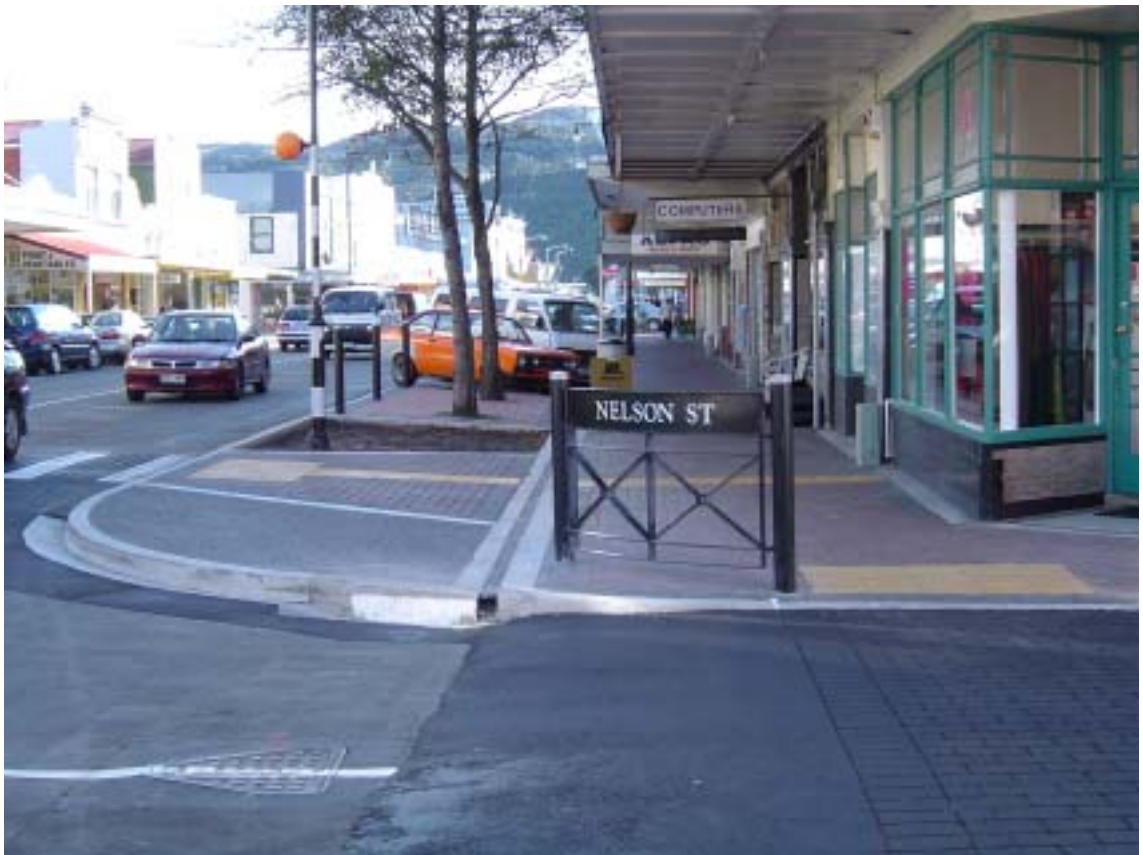
*Photo 16: This installation shows a textured and raised crossing surface to inform blind and vision-impaired pedestrians of the boundaries of the crossing point. Note also how street furniture (in this case fencing – with a compliant low level horizontal bar) has been used to divert pedestrians to the crossing point away from the trip hazard at the ramp up to the crossing point.*

Raised crossing platforms and ramps, especially those with a different surface material/texture from the adjoining section of road, can be particularly useful for guiding pedestrians and slowing traffic (photo 16).

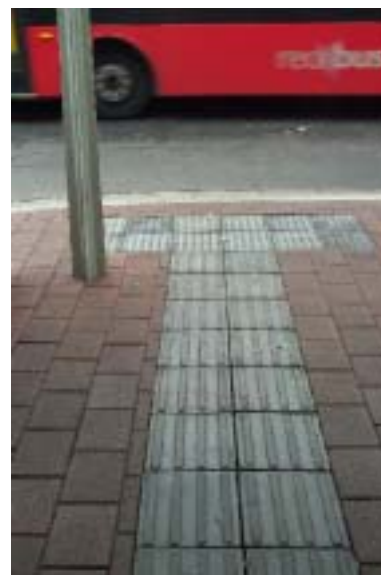
Photo 17: Directional indicators lead to warning indicators at a bus stop. Note the warning indicators are wider than required.

Photo 17 shows directional and warning indicators installed correctly at a bus stop.

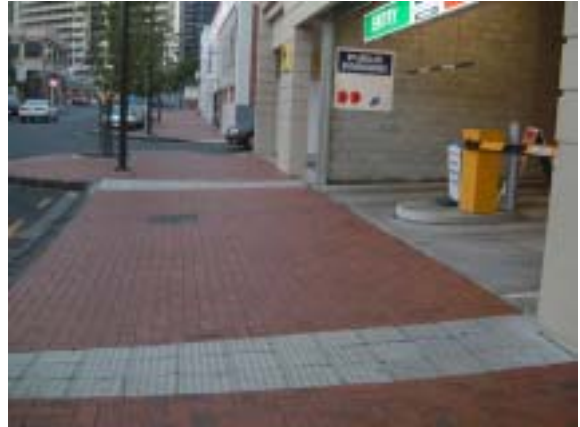
*Photo 18: Warning indicators extend across the full width of the footpath outside a car park building.*

- have a depth of 600mm and extend across the full width of the footpath, and
- be setback at least 300mm from the expected travel path of a large vehicle turning to enter or leave the vehicle crossing point.

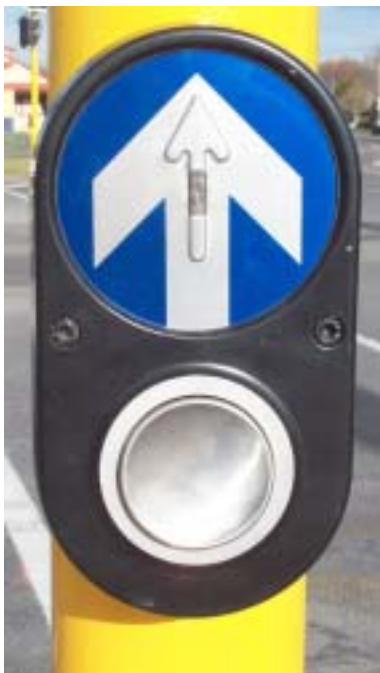
Photo 19: Pedestrian push-button assembly.

The standard pedestrian push-button assembly layout is shown in Photo 19 and Figure 6. It has an arrow above the push button. The main function of the arrow on the call box is to provide blind and vision-impaired pedestrians with directional orientation.
